**Subject: Revised Corrective Measures Pre-design Investigation Results Report Revision
and Responses to Comments**

ArvinMeritor, Inc.'s Responses to EPA Comments Draft Corrective Measures Pre-design Investigation Results Report

This Report has been prepared for the Grenada Manufacturing, LLC facility (Site) located at 635 Highway 332 in Grenada, Mississippi. The facility is undergoing Resource Conservation and Recovery Act (RCRA) corrective action for releases of hazardous waste, including hazardous constituents, from various Solid Waste Management Units (SWMUs). This report provides results from the activities outlined in the Corrective Measures Pre-Design Activities Work Plan (Work Plan), along with recommendations for further actions at the Site.

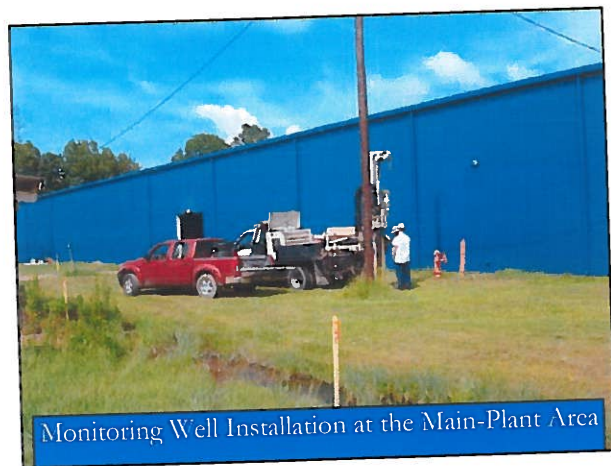
Figure 2-1. Main-Plant-Area Temporary Well Layout

Thirty-one temporary DNAPL detection wells were installed at the Main-Plant Area. The locations of those wells are shown in Figure 2-1. Thirty of the wells were installed on 30-foot centers in a grid pattern in between the Main-Plant Building, the warehouse, and Building No. 3. The grid included five rows oriented approximately north to south (identified as rows A through E) and six columns oriented approximately west to east (identified as columns 1 through 6). The temporary wells were labeled PTW-A1 through PTW-E6. The 31st temporary well was installed approximately 30 feet to the north, and in between, wells PTW-A5 and PTW-A6. That well was labeled PTW-AA5.

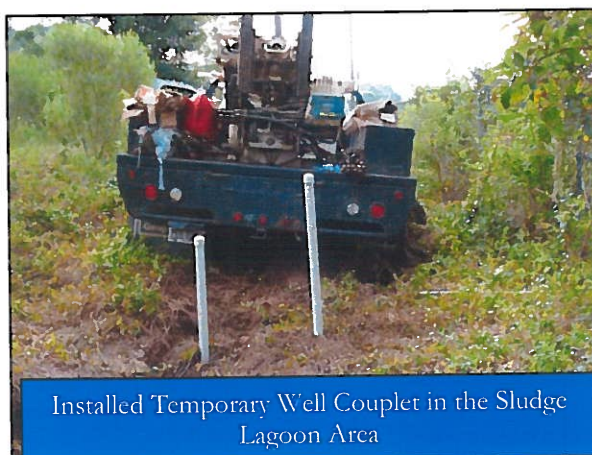
Figure 2-2. Lagoon-Area Temporary Wells

Nine temporary NAPL-detection well couplets were installed around the perimeter of the Sludge Lagoon as shown in Figure 2-2. Inclement weather conditions in July made the ground very soft, and maneuvering the Geoprobe® rig was extremely difficult. As a result, nine well couplets were installed in selected locations that provided adequate coverage around the lagoon to find and delineate the presence of NAPLs.

Each well couplet included a shallow LNAPL detection well that was completed with 10 feet of 0.01-inch slot well screen placed across the water table, and a DNAPL detection well consisting of approximately 10 feet of 0.010-slot well screen installed on top of the underlying hardpan clay. The bore hole associated with temporary DNAPL detection well LTW-8 was continuously sampled to the depth of refusal (i.e., when the hardpan clay was encountered) to verify that depth of drill-rod refusal corresponded to the top of the aquitard. The temporary wells were labeled LTW-1 through LTW-18, with the odd numbered wells representing the shallower LNAPL detection wells and the even numbered wells representing the deeper DNAPL detection wells. All temporary NAPL detection wells installed in the Sludge-Lagoon Area were completed as “stickups” and fitted with lockable J-plugs. Although it was originally intended to place the DNAPL wells into the hardpan to form a sump to collect DNAPL, it was discovered that the clay could not be penetrated to any significant depth to form a sump. To compensate for this, slots were cut into the well plugs to allow any DNAPL to enter the very bottom of the wells. This added approximately 0.4 feet to the effective screen length and placed the lower slots immediately above the clay, allowing detection of very thin DNAPL layers if they were present on the aquitard surface.

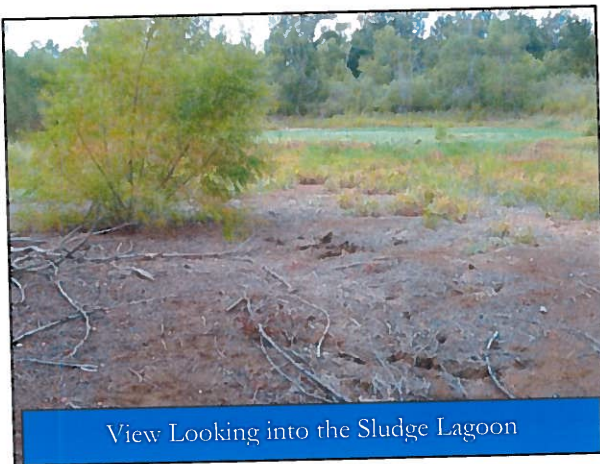
View Looking into the Sludge Lagoon

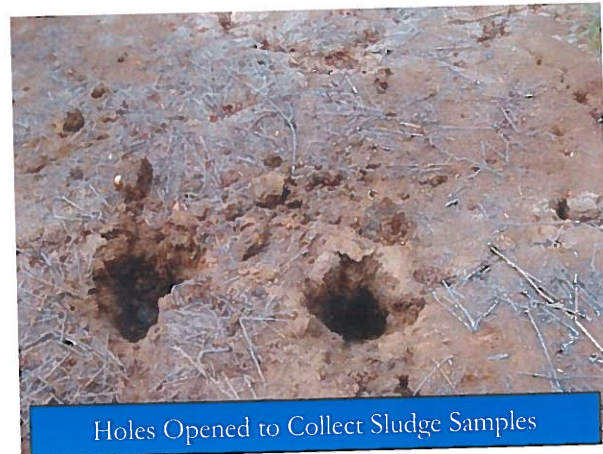
Figure 4-1. Sampling Locations for the Bench-Scale Sludge-Treatability Studies

In August 2007, sludge samples were collected from the three locations within the Sludge Lagoon as shown in Figure 4-1. The samples were identified as L-1 NE for the sample collected from the northeast corner of

the lagoon, L-2 NW for the sample collected from the northwest corner, and L-3 SE for the sample collected from the southeast corner of the lagoon. The samples were collected with a hand shovel by first removing the soil layer covering the sediment and then digging out the sediment and transferring it to 5-gallon plastic buckets. Two buckets were collected at each location with each bucket collected from a dedicated hole, resulting in a total volume of 10 gallons of sample per location. The buckets were labeled and sent under chain-of-custody procedures to KEMRON Environmental Services' laboratories in Atlanta, Georgia for physical/chemical properties analyses and bench-scale stabilization testing as described below. The final technical report from KEMRON Environmental Services provides detailed descriptions of the sample processing, experimental testing, and analytical methodologies along with a comprehensive discussion of the results. A copy of the report is in Appendix C.

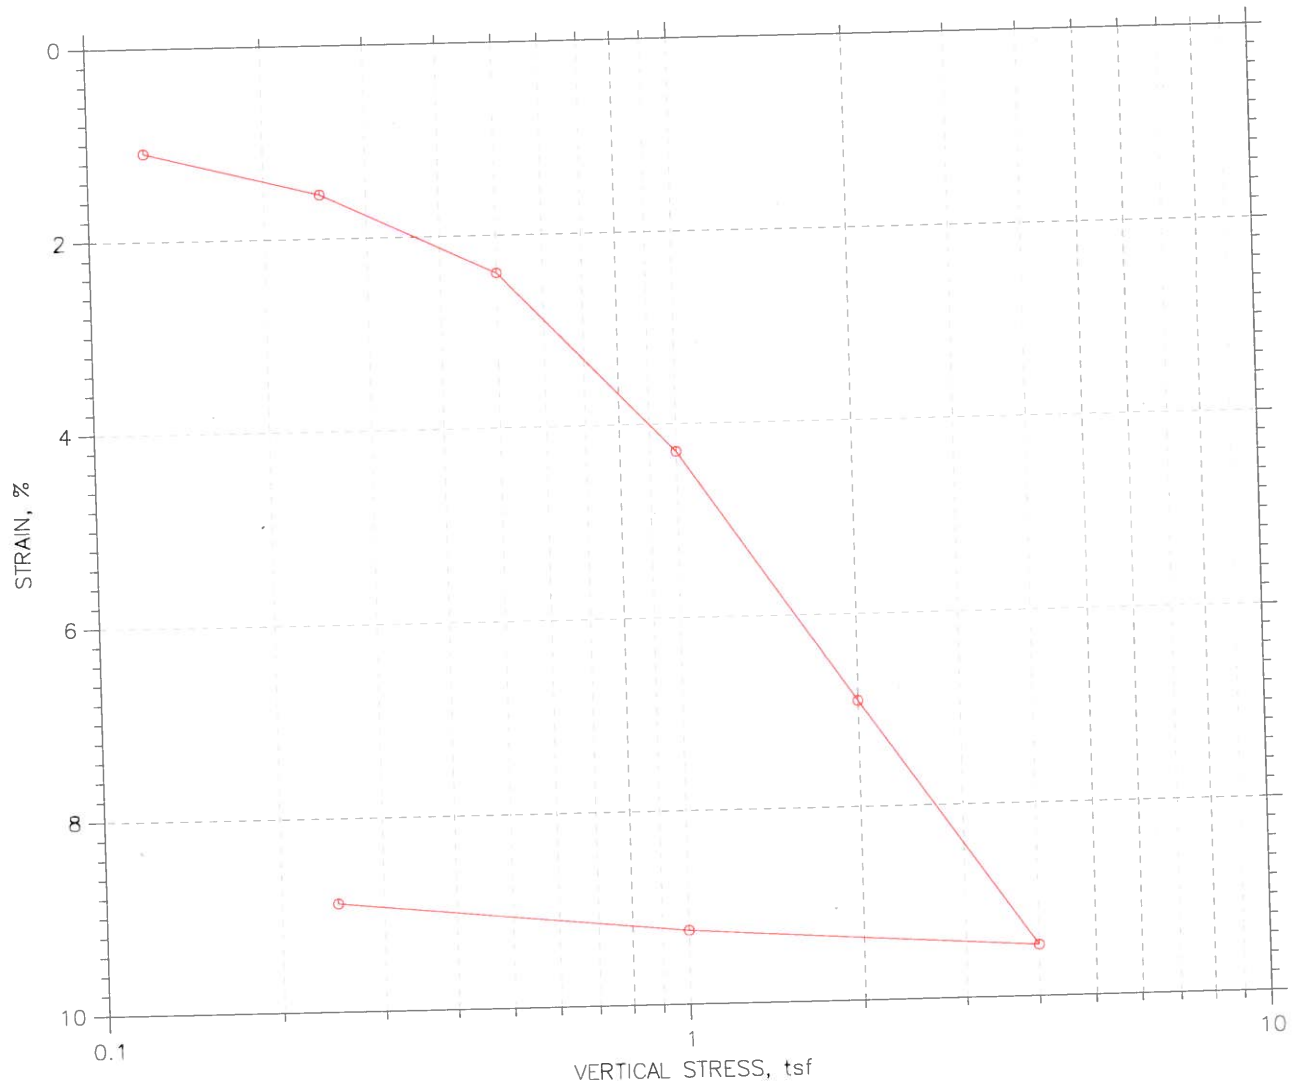
Before Test	After Test
Overburden Pressure: 0 tsf				114.82	108.31
Preconsolidation Pressure: 0 tsf				36.15	39.67
Compression Index: 0				85.54	91.09
Diameter: 2.5 in				3.49	3.09
Height: 1.008 in					
LL: NP					
PL: NP					
PI: NP					
GS: 2.60

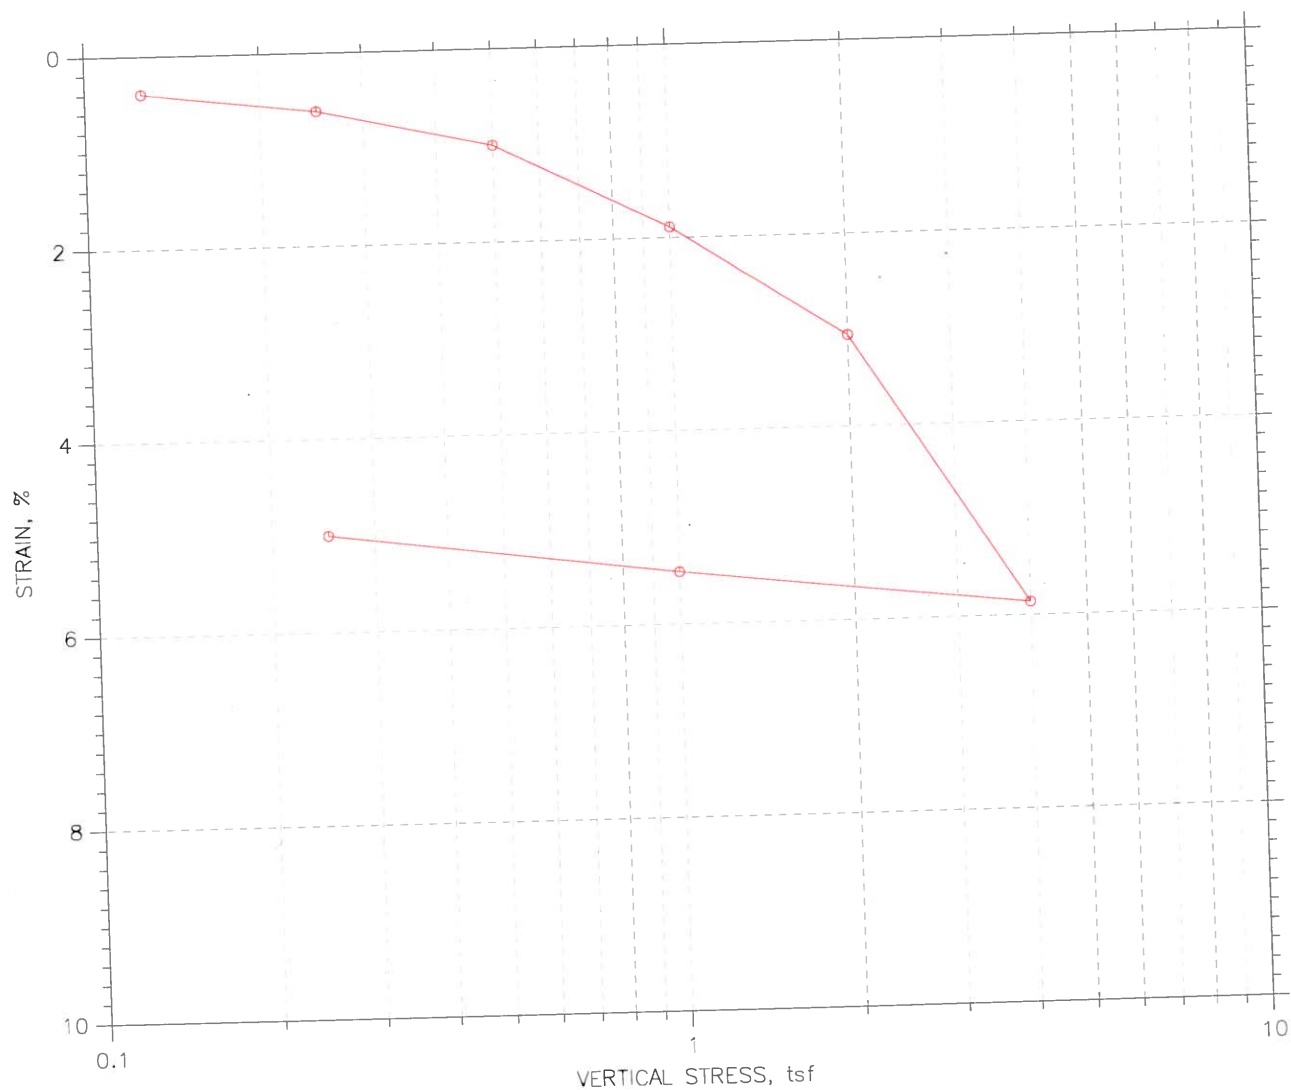
Before Test	After Test
Overburden Pressure: 0 tsf				119.03	114.10
Preconsolidation Pressure: 0 tsf				36.22	38.13
Compression Index: 0				88.89	91.08
Diameter: 2.5 in				3.48	3.26
Height: 1.009 in					
LL: NP	PL: NP	PI: NP	GS: 2.60

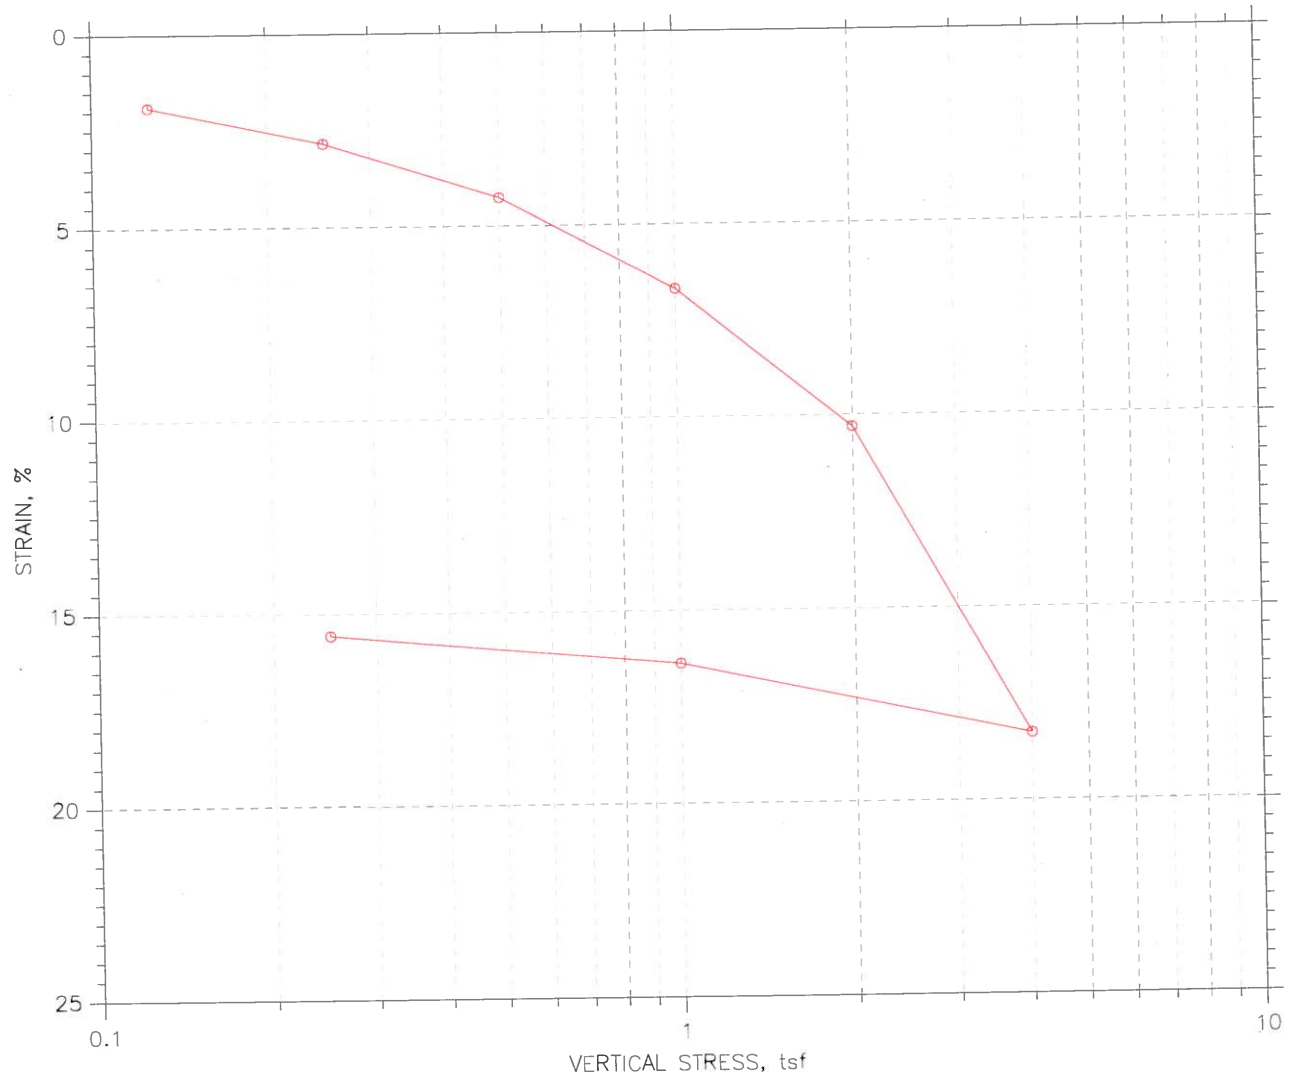
Before Test	After Test
Overburden Pressure: 0 tsf				158.77	126.92
Preconsolidation Pressure: 0 tsf				30.48	36.11
Compression Index: 0				95.43	94.40
Diameter: 2.5 in		Height: 1 in		4.33	3.50
LL: NP	PL: NP	PI: NP	GS: 2.60

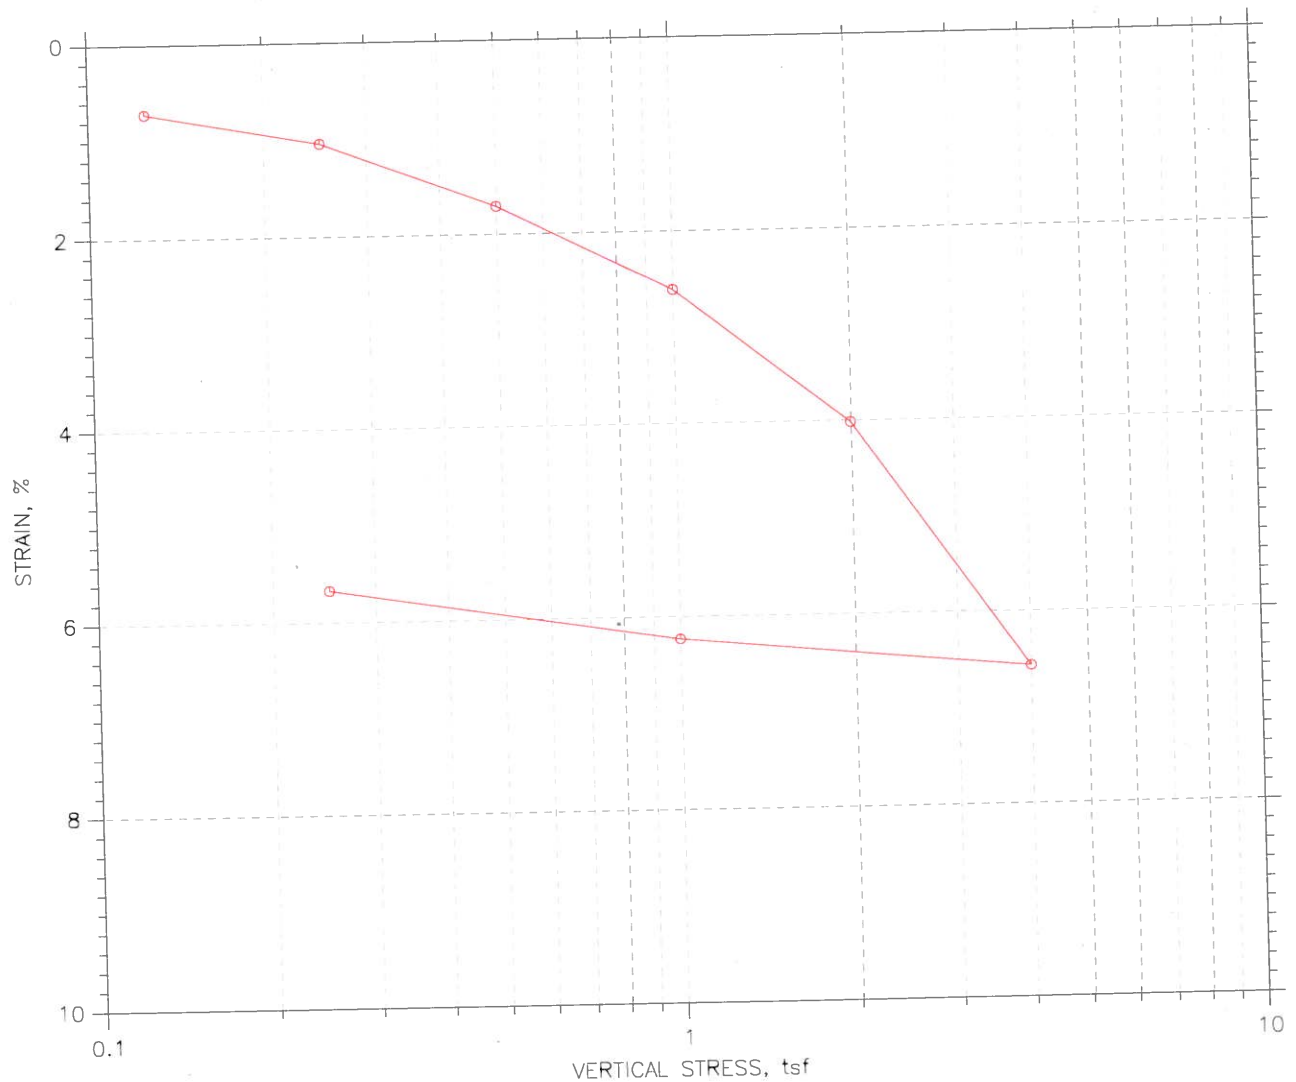
Before Test	After Test
Overburden Pressure: 0 tsf				133.02	127.96
Preconsolidation Pressure: 0 tsf				33.35	35.35
Compression Index: 0				89.43	92.64
Diameter: 2.5 in		Height: 1.003 in		3.87	3.59
LL: NP	PL: NP	PI: NP	GS: 2.60

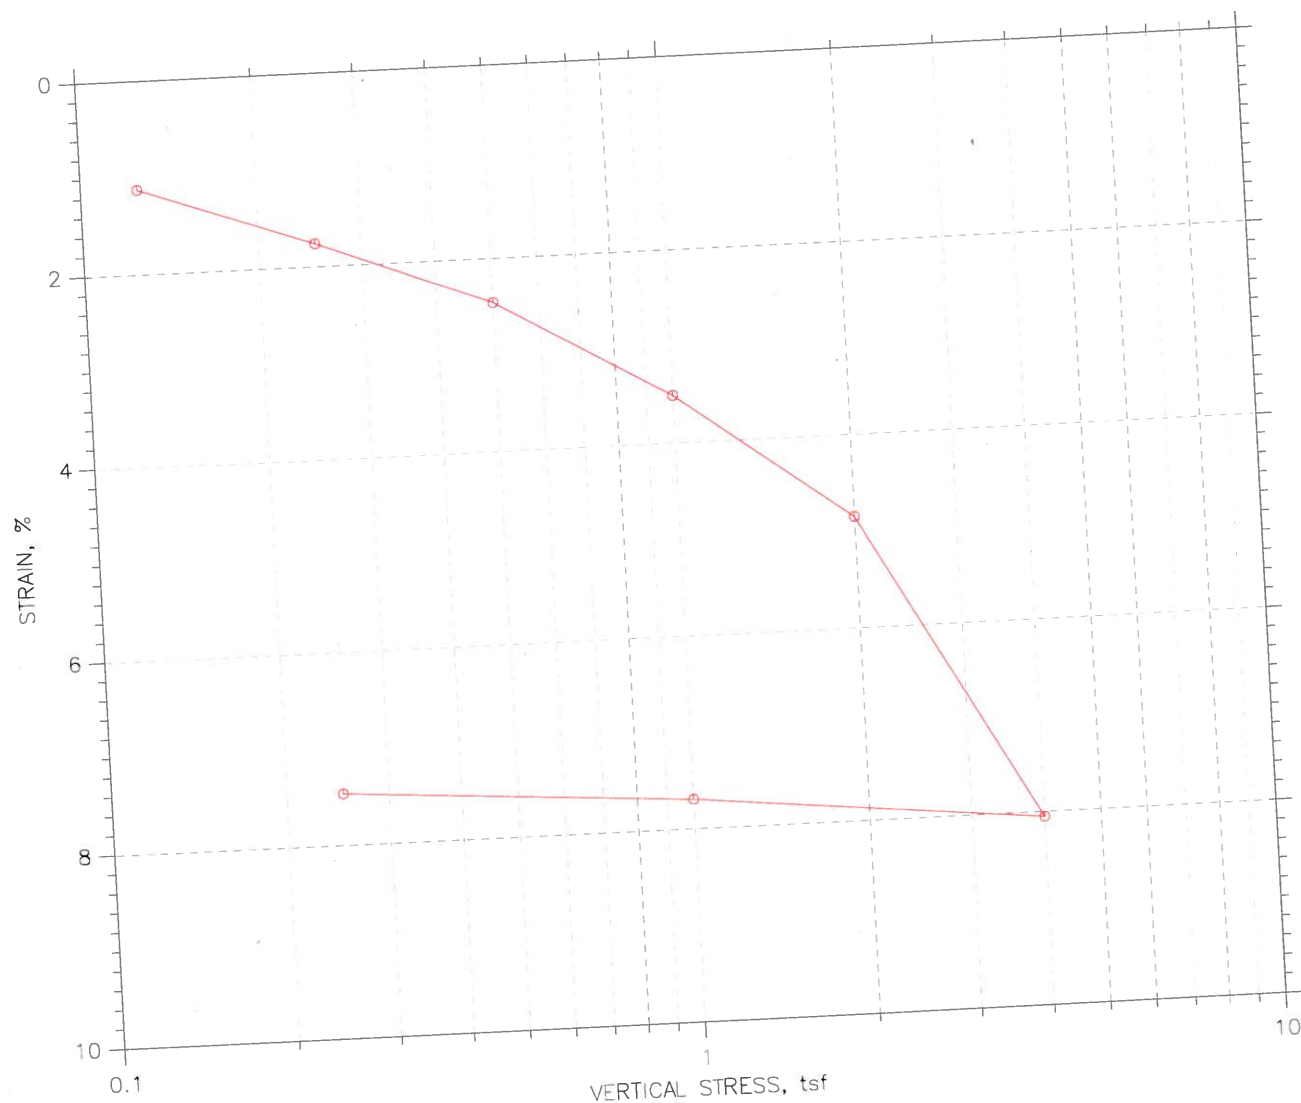
Before Test	After Test
Overburden Pressure: 0 tsf				120.85	115.53
Preconsolidation Pressure: 0 tsf				35.78	38.66
Compression Index: 0				88.84	93.92
Diameter: 2.5 in				3.54	3.20
Height: 1.01 in					
LL: NP					
PL: NP					
PI: NP					
GS: 2.60

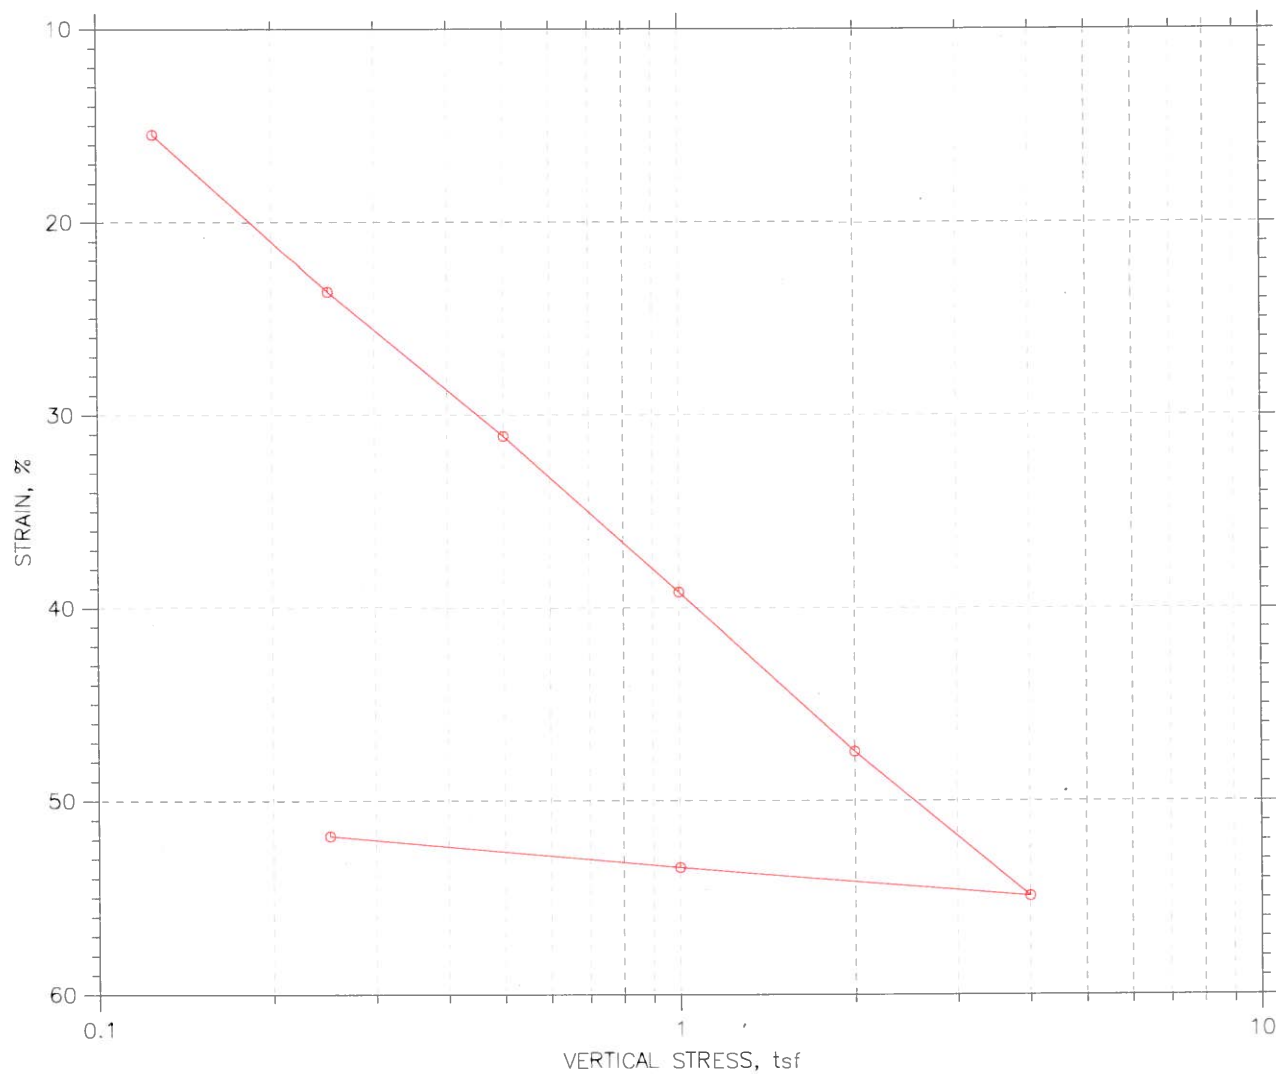
Before Test	After Test
Overburden Pressure: 0 tsf				480.44	144.50
Preconsolidation Pressure: 0 tsf				11.91	24.72
Compression Index: 0				98.89	67.51
Diameter: 2.5 in	Height: 1 in			12.63	5.57
LL: NP	PL: NP	PI: NP	GS: 2.60

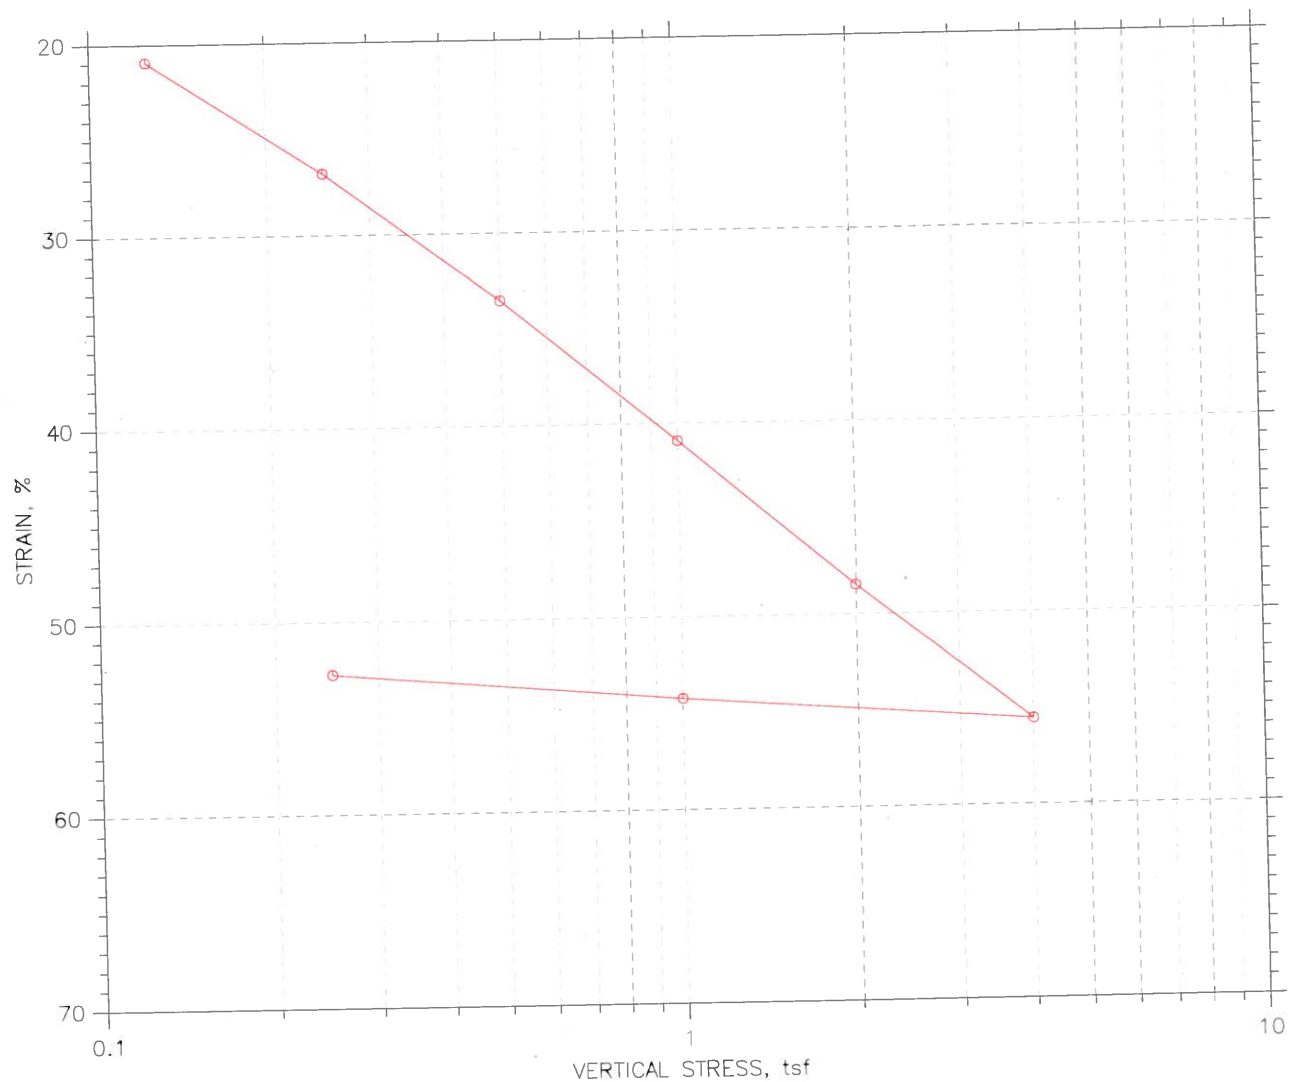
Before Test	After Test
Overburden Pressure: 0 tsf				352.62	125.27
Preconsolidation Pressure: 0 tsf				15.72	33.27
Compression Index: 0				98.34	83.97
Diameter: 2.5 in		Height: 1 in		9.32	3.88
LL: NP	PL: NP	PI: NP	GS: 2.60
